## Technological University of Shannon: Removing Red Algae for a Cleaner Campus

Technological University of Shannon (TUS) Thurles Campus faced persistent red algae staining on stone stairs and building facades, a common issue in Ireland's damp climate. The orange-red patches looked unsightly and could become slippery when wet, posing safety risks. TUS aimed to remove the algae thoroughly, prevent its return and avoid harsh chemicals, in line with its sustainability goals and operational needs.

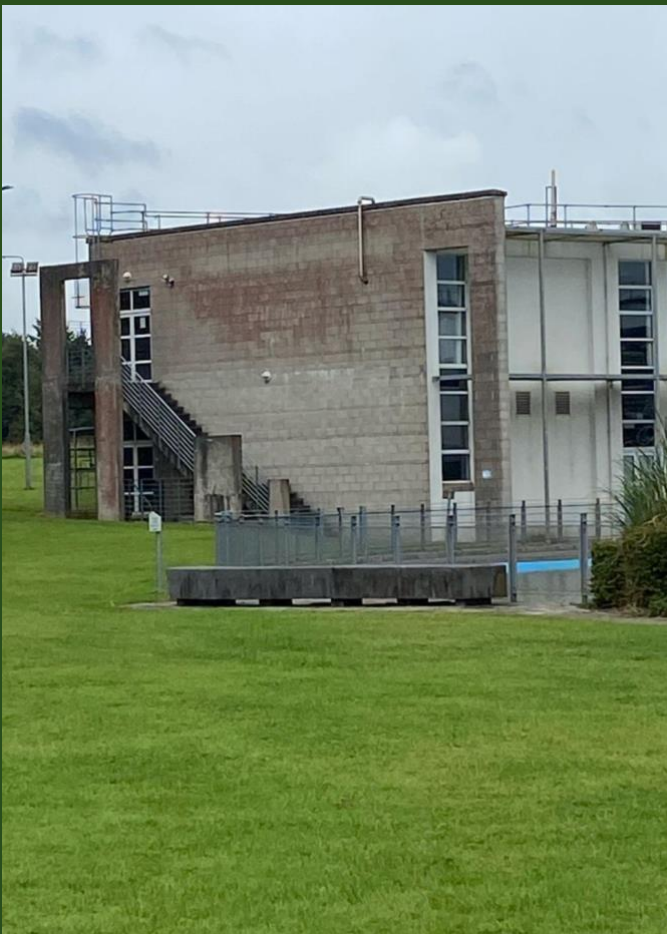
**Before**

- **Red Algae Staining:** *Trentepohlia* algae had stained steps and walls with a vivid red/orange hue. It thrives in moist, shaded areas and is tough to remove.
- **Safety and Appearance:** The algae created slippery surfaces and made the buildings look neglected, unacceptable for a modern, well-maintained campus.
- **Ineffective Conventional Methods:** Power washing alone wouldn't kill spores. Chemical cleaners could pose health risks, require cordoning off and contradict sustainability policies. TUS needed an effective, non-invasive alternative suitable for use during normal operations.

- **Initial Cleaning:** Hot water was applied to the affected stone to break up grime and kill surface algae. The method was safe for use during regular campus hours with no disruption.
- **Biocide Application:** A low-pressure spray of biodegradable biocide followed to kill spores and provide ongoing protection. The product, widely used in horticulture, was safe once dried and left no harmful residue.

- **Final Rinse and Monitoring:** After curing time, the area was rinsed. Stone surfaces were visibly restored, and algae regrowth was minimal over the following weeks. Untreated test patches confirmed the biocide's effectiveness in preventing return growth.

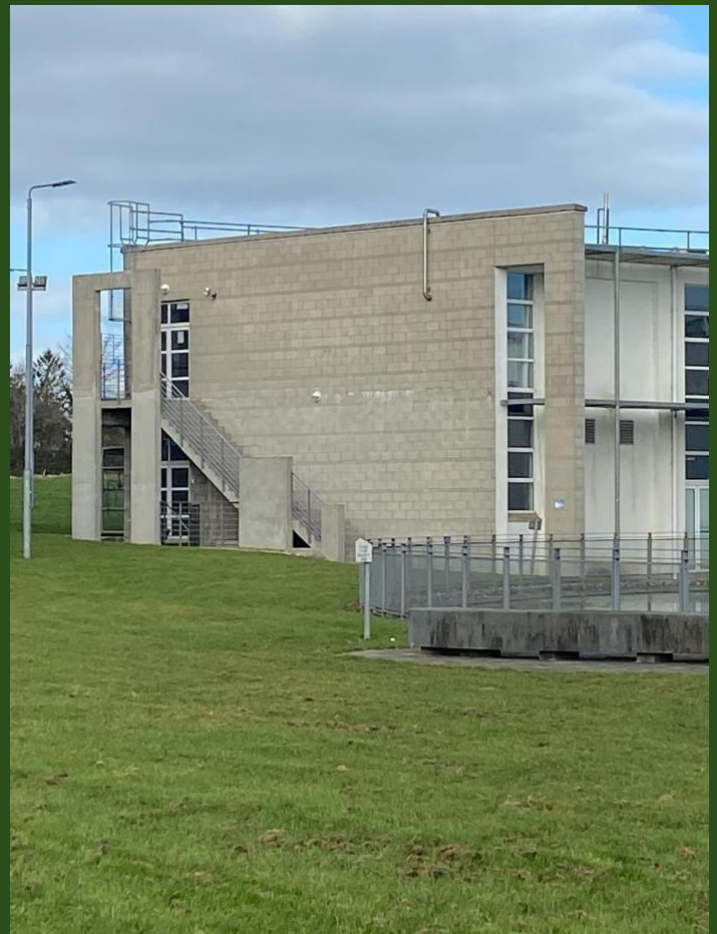
**After**

The transformation was clear. Stairs and walls returned to their natural colour, and slip risks were eliminated. The cleaned entrance area looked brighter and more welcoming. The treatment's residual effect kept surfaces clear through autumn, reducing future maintenance needs.
